# Slope Movement Characteristics and Models based on Engineering- geological Properties of the Menoreh Hills, Purworejo Regency, Central Java, Indonesia

Sari Bahagiarti Kusumayudha<sup>1</sup>, Ayu Narwastu Ciptahening<sup>1</sup>, Heru Sigit Purwanto<sup>1</sup>, Wisnu Aji Kristanto<sup>1</sup>, Nandra Eko Nugroho<sup>1</sup>

Universitas Pembangunan Nasional Veteran Yogyakarta

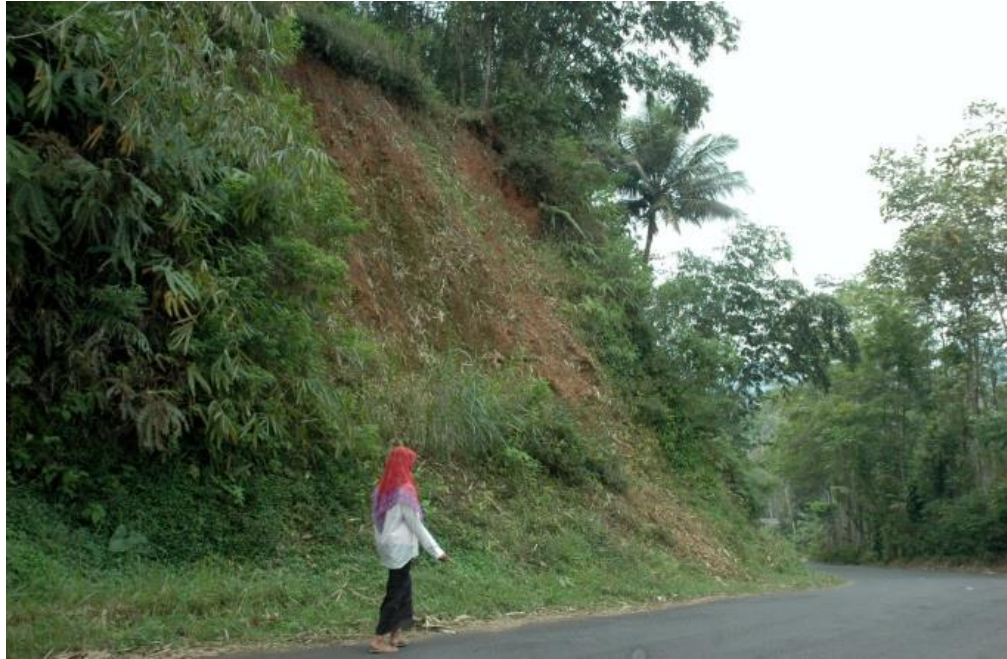
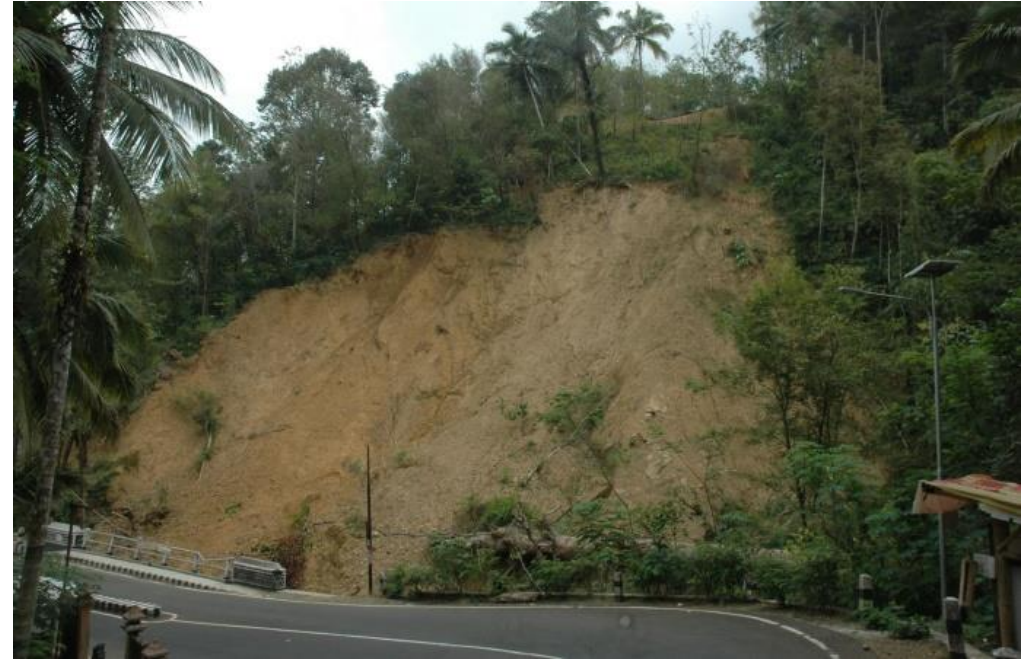
# Typical Landslides involving thin soil (left), and involving thick soil (right) found at the main road of Kaligesing District

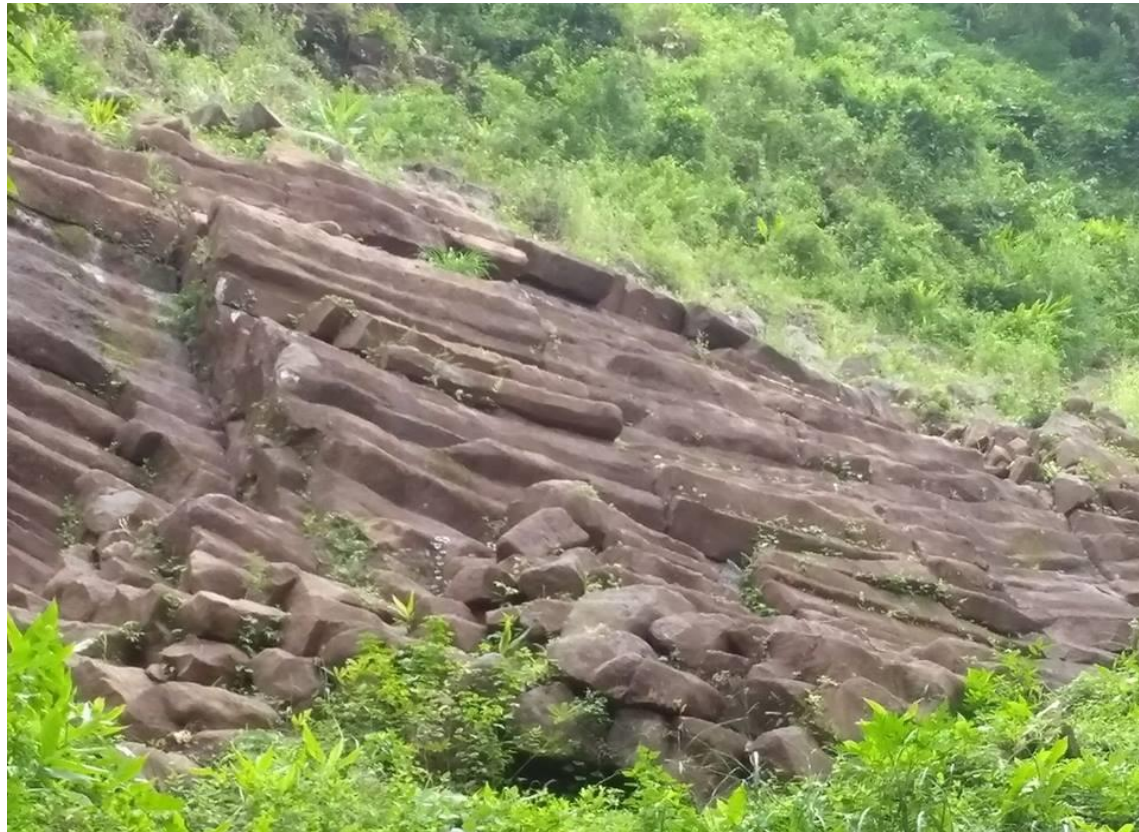
# Lava with columnar joint structure, exposed after landslide occurrence 2016 in Sidamulya village, Purworejo District
